Proper Functioning Condition
And
Amendment 6 Assessments and Ratings
For
Mulkey Allotment
Summer 2011

Prepared by: Lisa Sims, Inyo National Forest Aquatic Biologist

December 2011

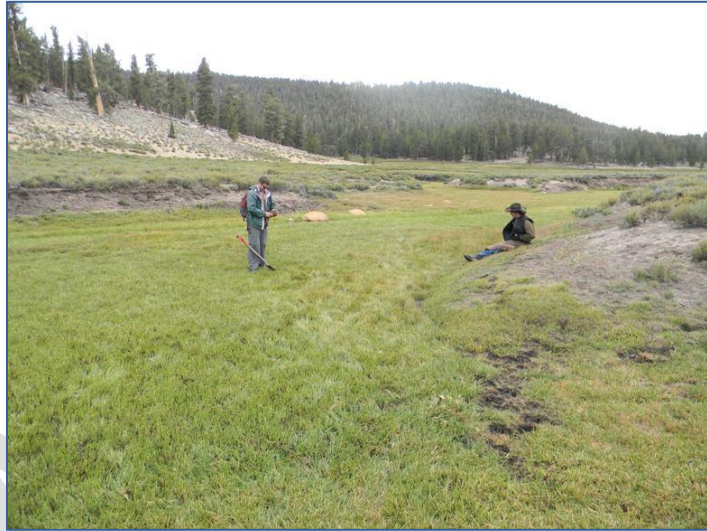
Photo above: Location of Amendment 6 assessment within Relict Organic Soils (MU19) ecological type.

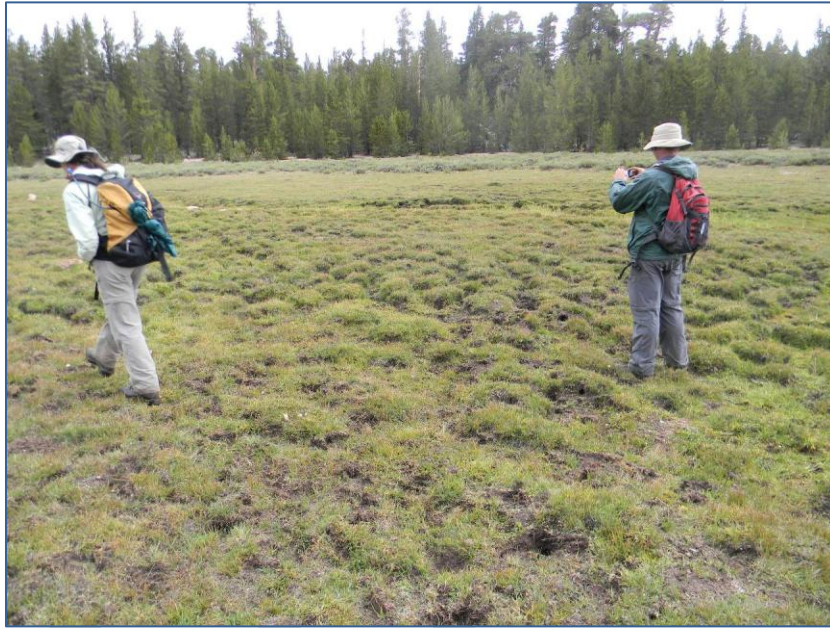
Although the Key Area that was assessed was in Fully Functional condition, there are some concerns with headcuts and hummocks within the upper, drier portion of the meadow (as noted on the map). Treated headcuts and some nickpoints were also observed, but compaction and sod layer were not measured to get an overall rating for this portion of the meadow. This portion of the meadow occurred in an area where the drainageway narrowed which may cause concentrated use by cattle (i.e., because of the morphology of the meadow). The dry meadow above this constricted area did not exhibit the same impacts, indicating that this condition appeared to be isolated from the majority of the Ash Meadow complex.

Photo above: Area of hummocks in the constricted drainageway (MU19) portion of Ash Meadow but is outside of the key area.

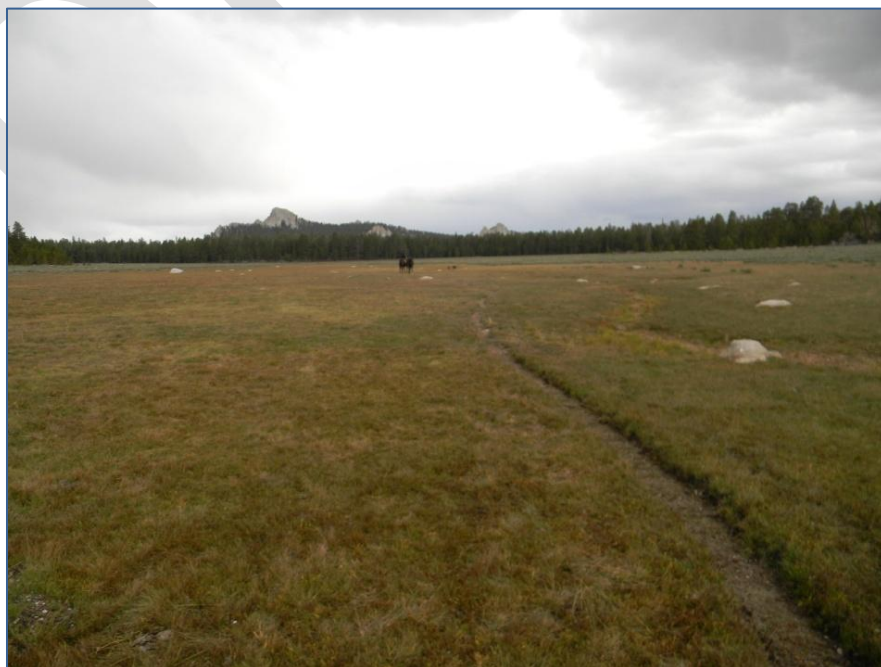
Photo above: Overview photo of the most western arm of Ash Meadow, exhibiting good vegetation cover in a drier ecological type.

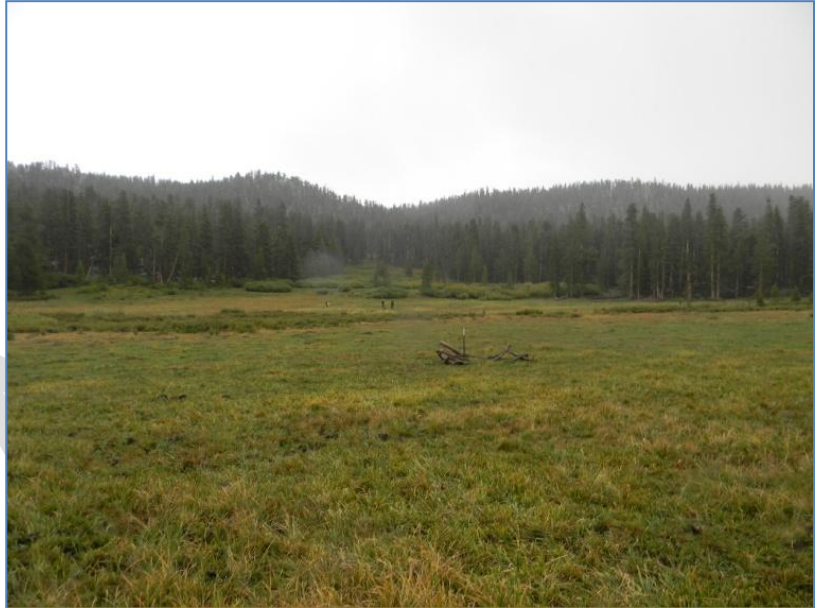
Photo above: Overview of Bear Meadow.

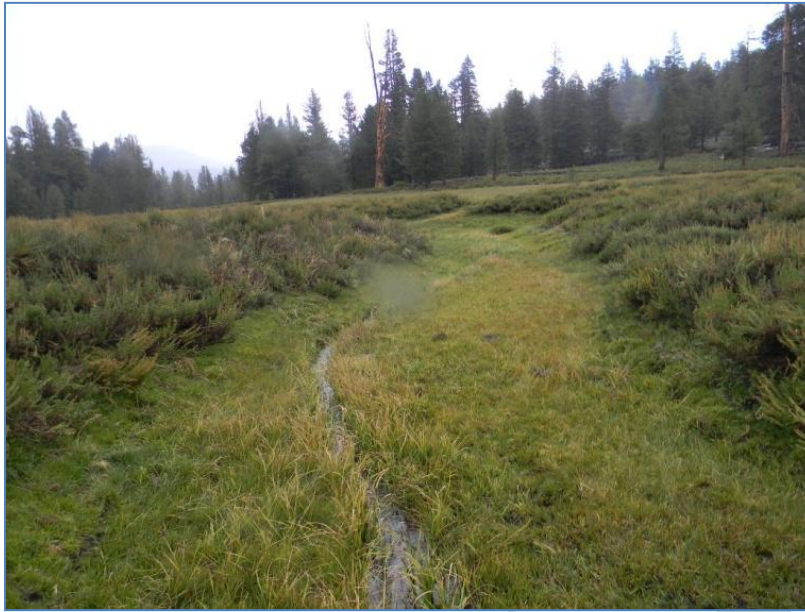
Photo above: Incised channel displays recovery with stabilizing vegetation.

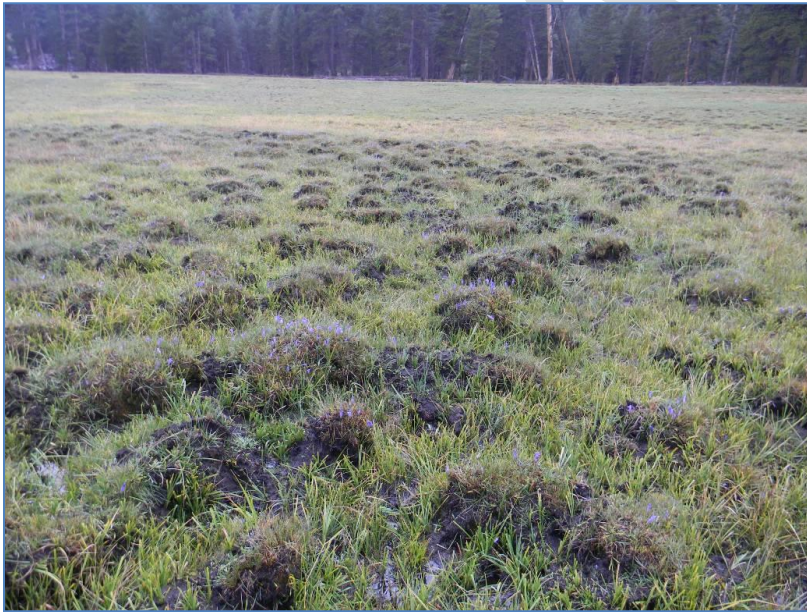
Photo above: Area of hummocks in Bear Meadow.

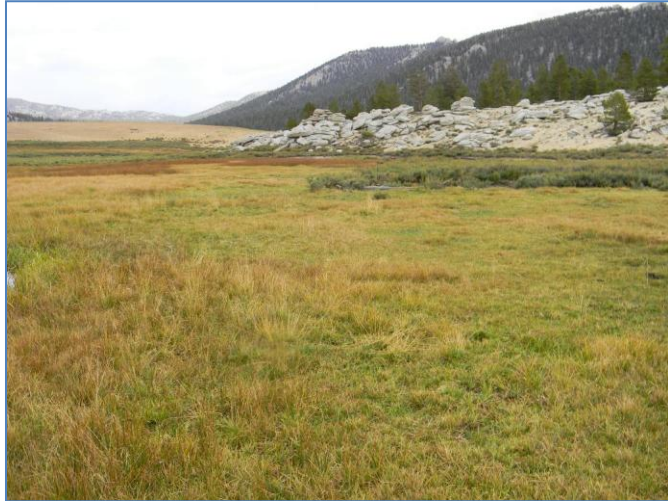
Photo above: Looking east across Bullfrog Meadow.

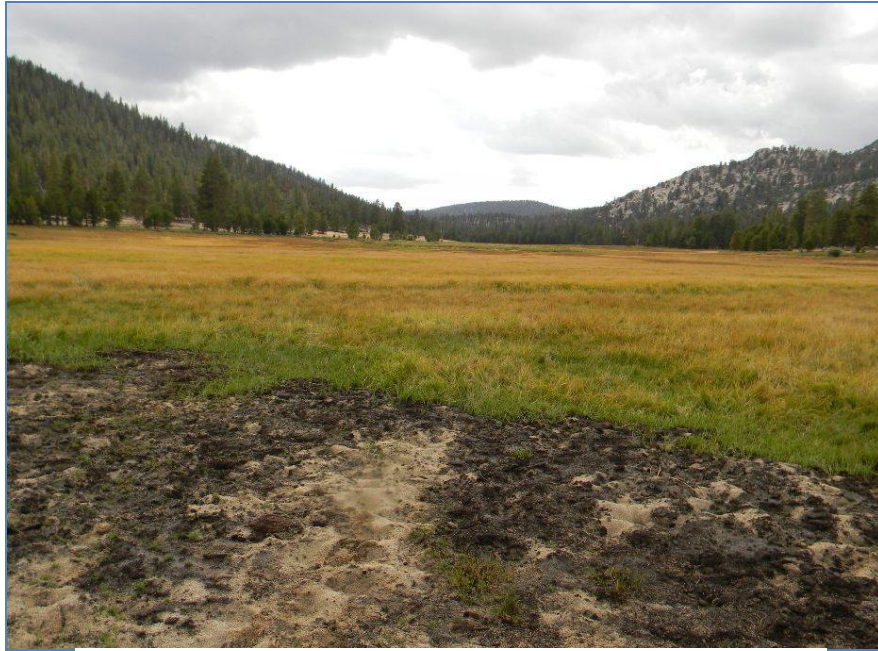
Photo above: Bullfrog Meadow looking west. In the foreground the alluvial deposits from 2011 flood event on July 6 are visible.

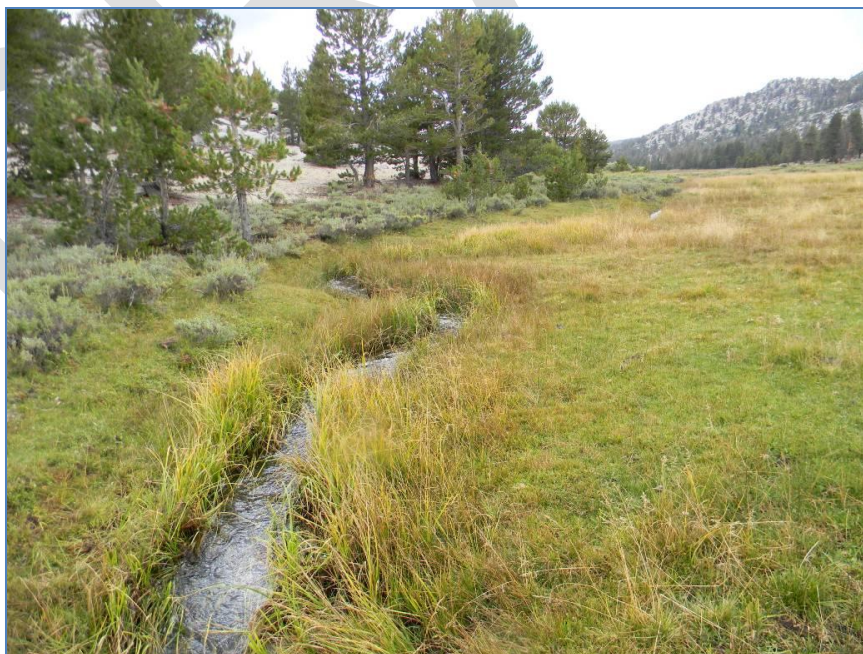
PFC Rating: The channel rated as Proper Functioning Condition with heavily vegetated streambanks noted. Headcuts within the stream channel were still evident, although stabilizing treatments were completed in the 1980s and 2000s. They remained stable with no migration during the 2011 runoff events.

Photo above: Bullfrog Creek in the section above the treated headcuts.

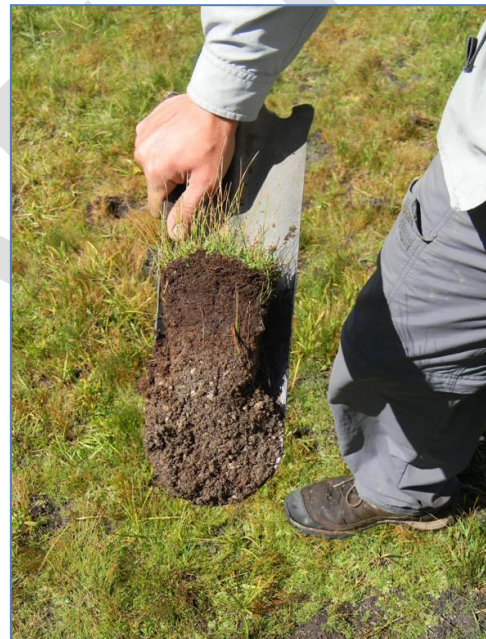
Photo above: Soil sample from Diaz meadow from the drier margins of the meadow.

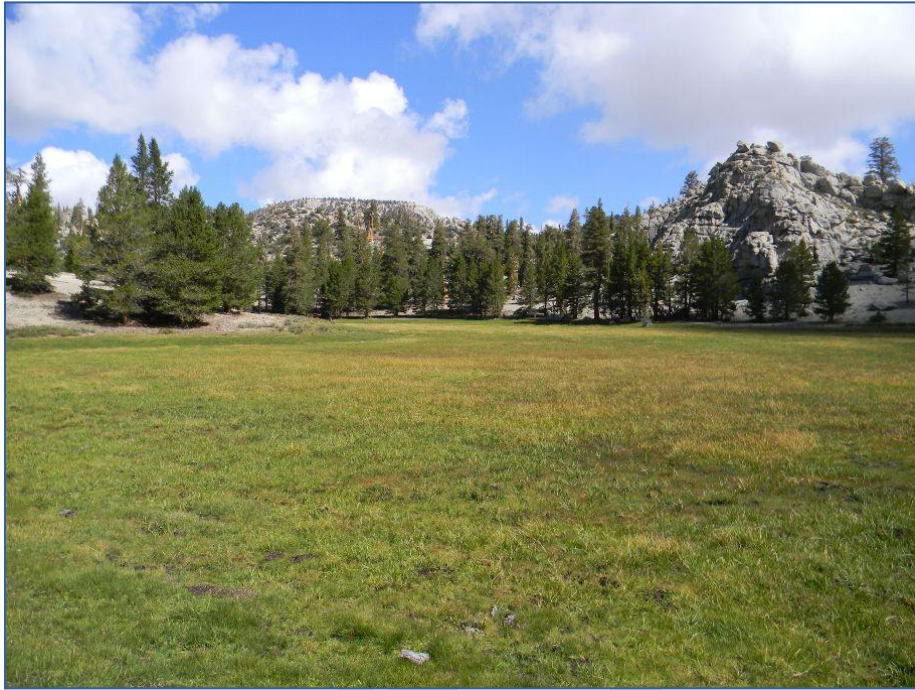
Photo above: Overview of Diaz Meadow. The “Frog Pond” is to the right of the frame.

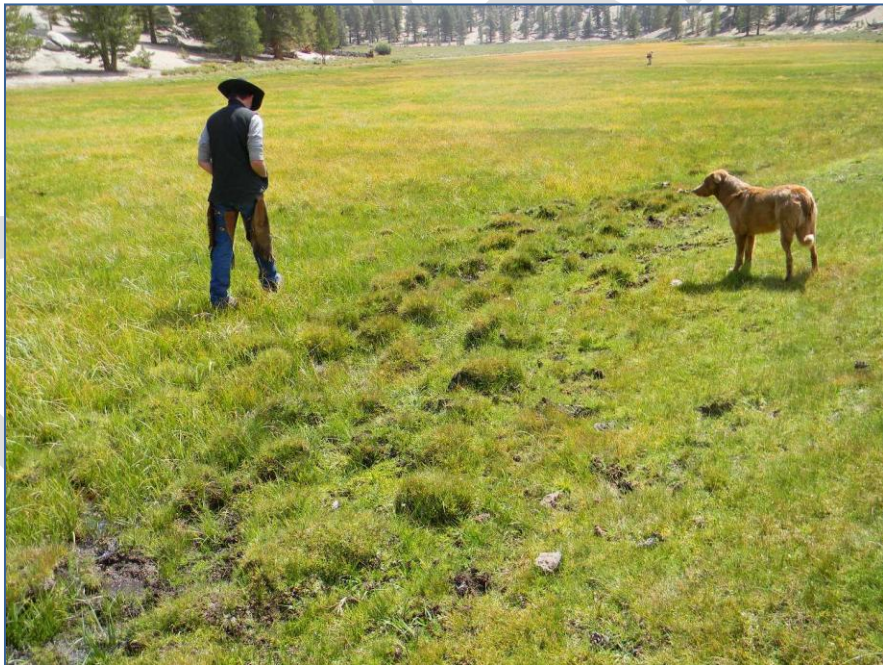
Photo above: Hummocks within Diaz Meadow were restricted to the margins of the meadow.

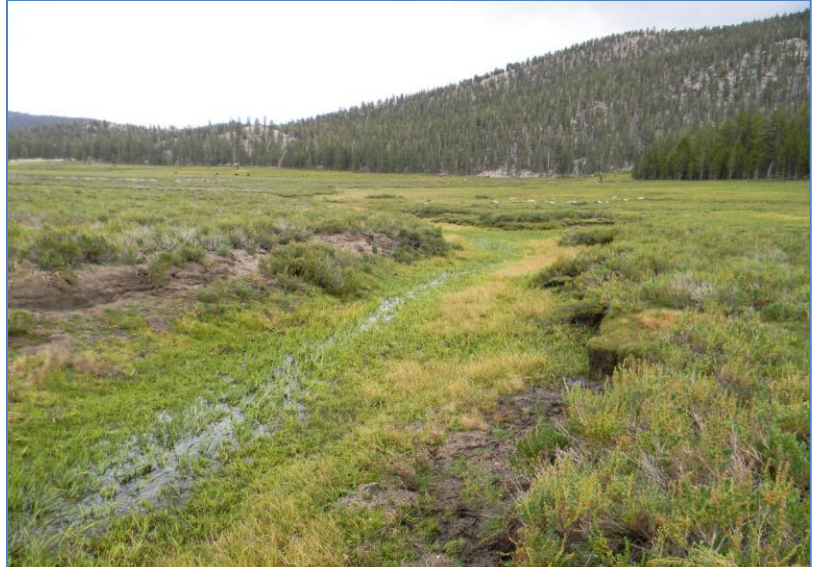
Photo above: Horseshoe Meadow looking down an incised spring channel that is exhibiting vegetation recovery.

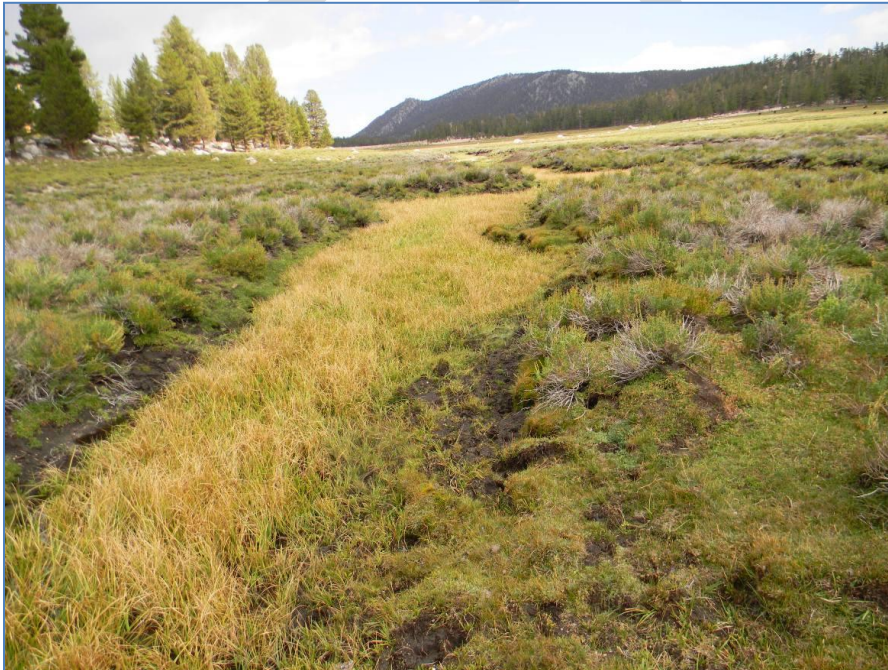
Photo above: Good vegetation cover within channel with rodent activity obvious in foreground of photo.

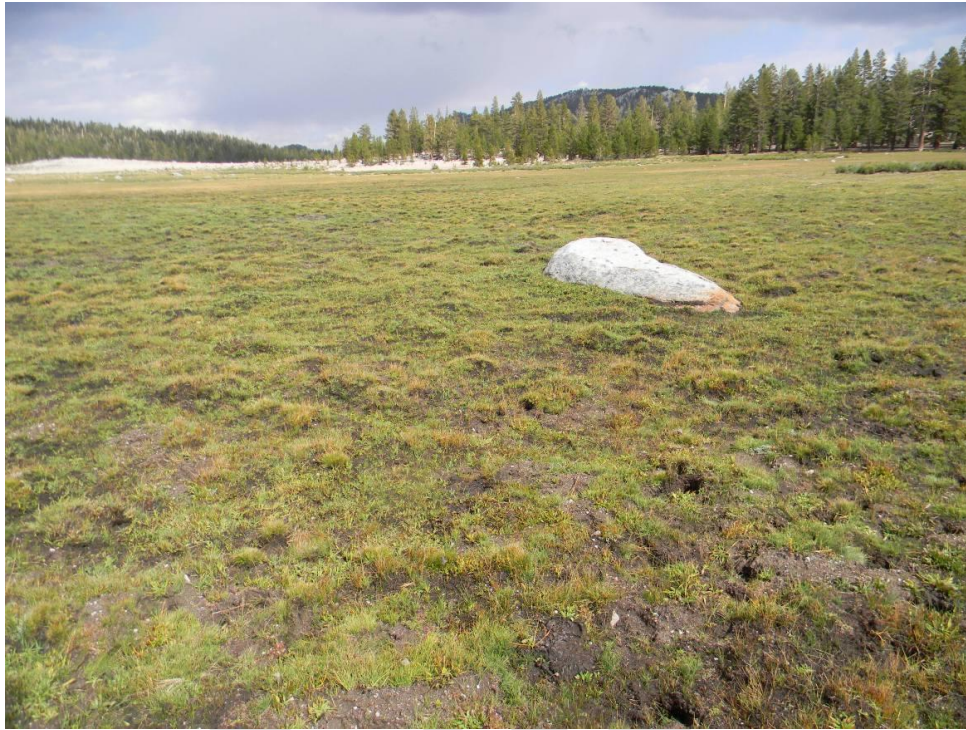
Photo above: Overview of Horseshoe Meadow in drier portion of the meadow that exhibits evidence of extensive rodent activity.

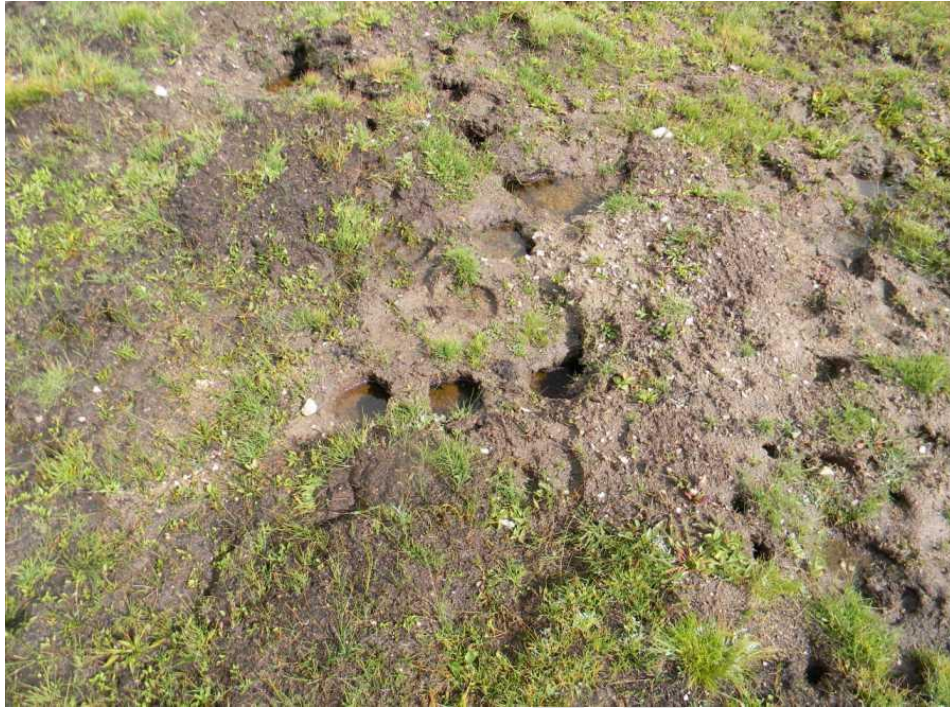
Photo above: Close-up of ground from photo above. Collapsed rodent burrows are evident and more susceptible to impacts because of the wet conditions in 2011.

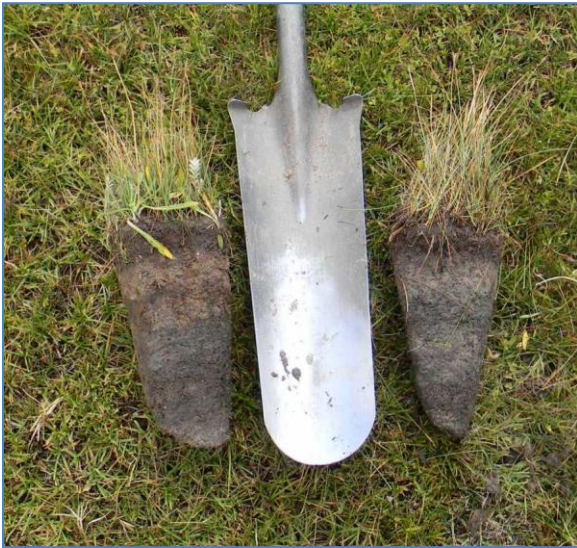
- **Compaction:** Compaction of the soil was observed only in the trailing areas between some of the hummocked areas but not within the meadow area. Also worth noting was that when comparing two soil samples between the grazed meadow and the meadow within the exclosure for compaction and rooting depth, no differences were observed except that there appeared to be more weedy species in the sample taken within the exclosure.

Photo left: Two soil samples from Mulkey Meadow: the left is from inside the exclosure, the right is from outside the exclosure in a cattle congregating area.

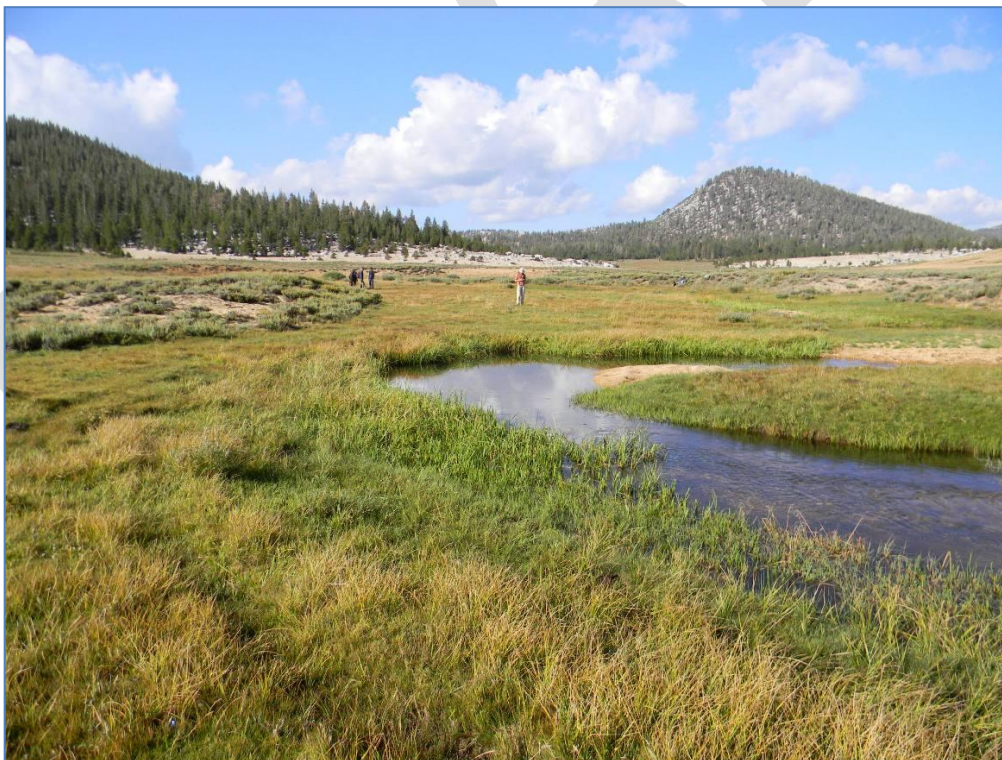
Photo above: Overview of the assessment area within Mulkey Meadow. Note areas of deposition on the steambanks from the 2011 flood event.

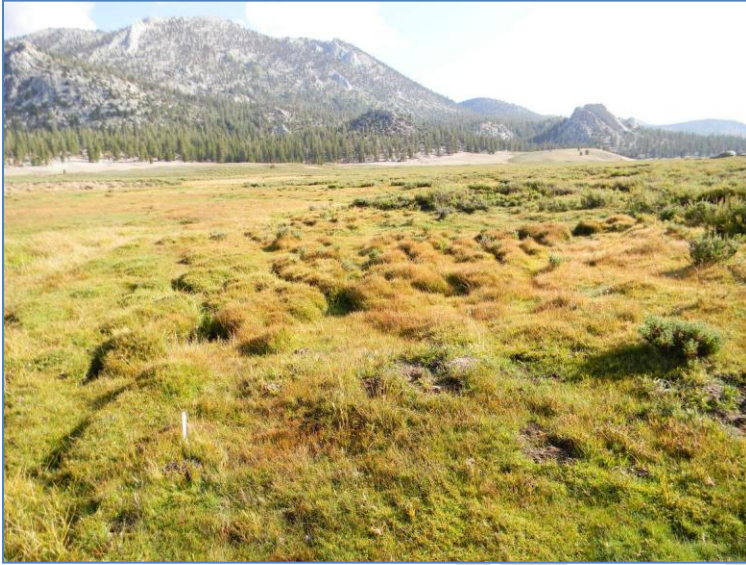
- **Hummocks:** Two areas of hummocks were observed and were quite developed, but isolated from the rest of the meadow. One area of hummocks appeared to be an old trailing location. Other areas where hummocks were observed included wet stringer areas.

Photo above: An area of hummocks located about 100 yards above the enclosure within Mulkey Meadow. The hummocks were well-vegetated and appeared to be created by trailing activities.

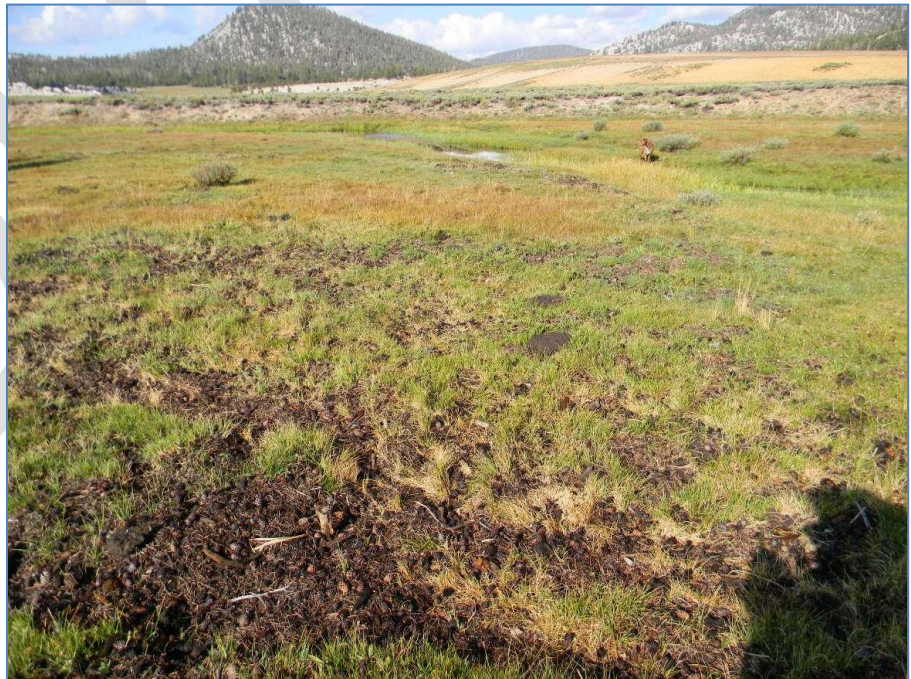
Photo above: The dark area of deposition indicated the level of the water during the July 6, 2011 flood event, and demonstrated the effectiveness of the floodplain at catching sediment and organic debris, an important component for floodplain development.

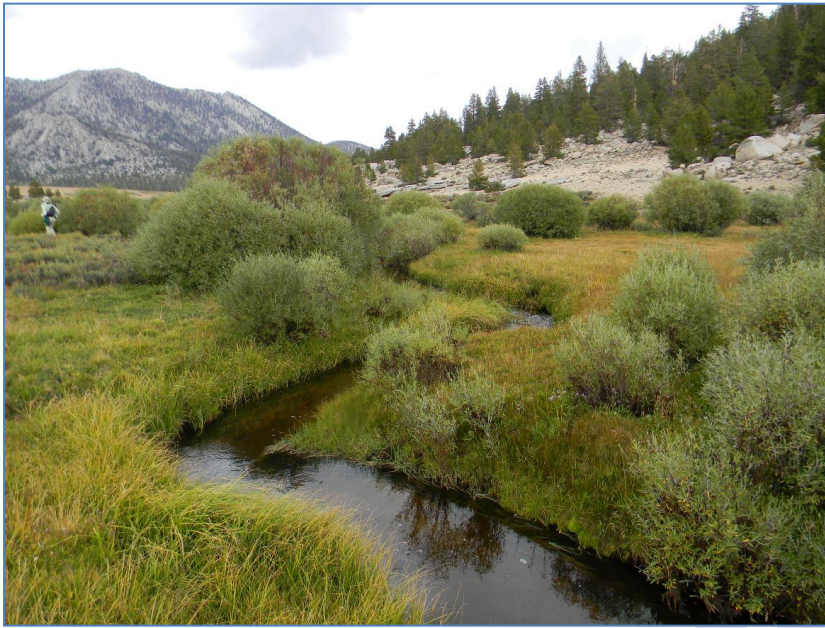
Photos for Mulkey Creek, inside enclosure, PFC

Photo above: Taken towards the bottom end within the enclosure in Mulkey Meadow.

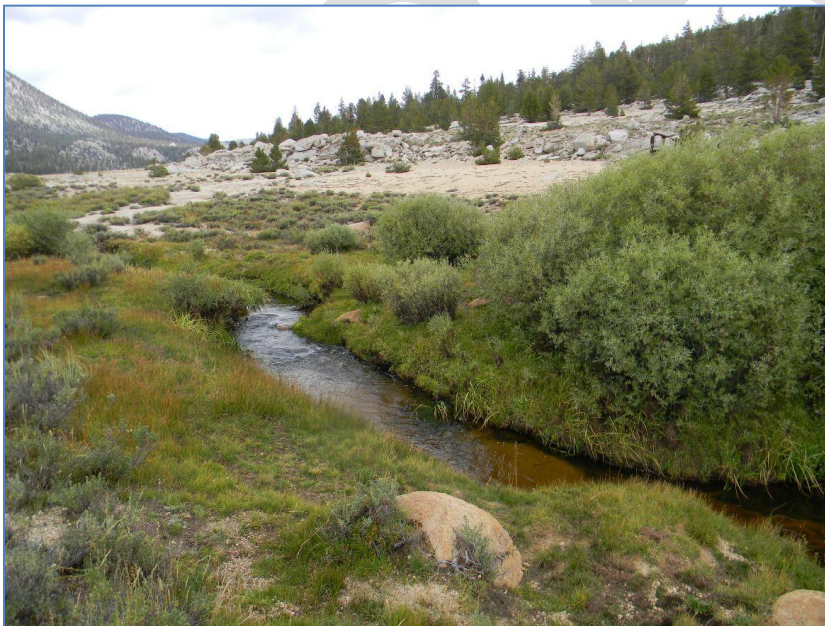
Photo above: Taken within the middle section of the Mulkey Meadow enclosure where the channel exhibits a higher gradient.

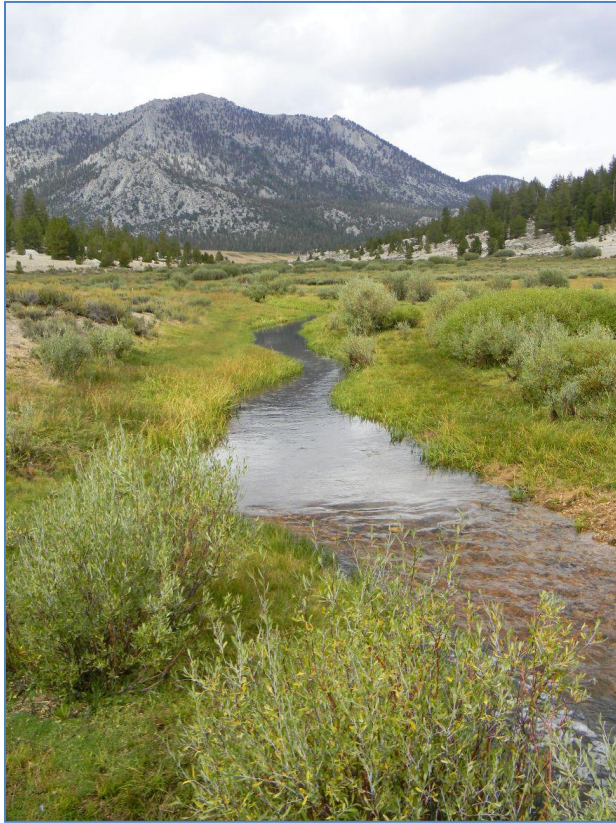
Photos for Lower Mulkey Creek PFC

Photo above: Streambanks and developing floodplain in lower Mulkey Meadow.

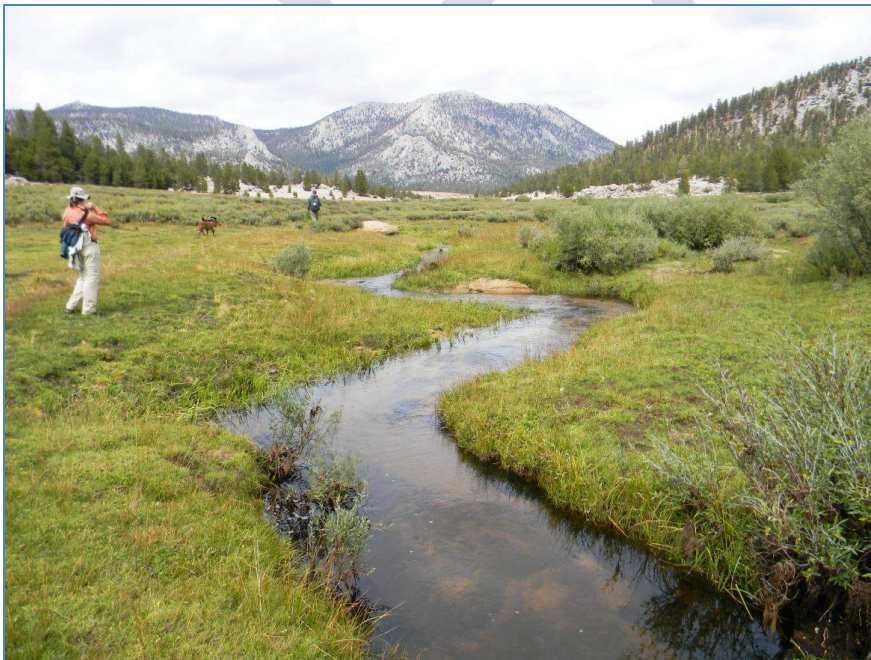
Photo above: Near the “upper end” of lower Mulkey Meadow, channel displayed well-developed floodplains and sinuosity.

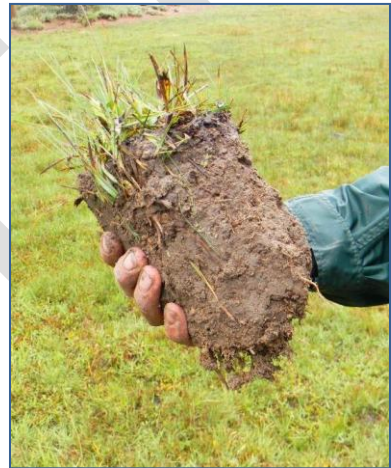
Photo above: Soil sample from MU19 ecological type, taken at location of current-year “hoof punch”.

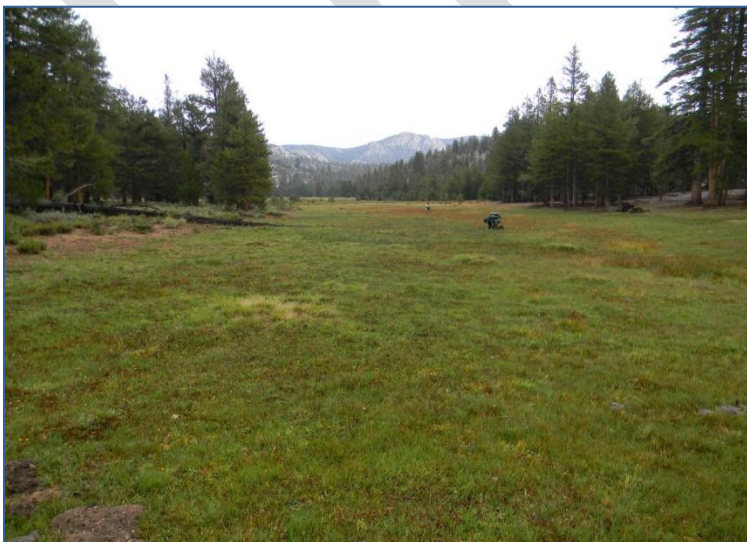
Photo above: Overview of Overholster Meadow in MU19 type.

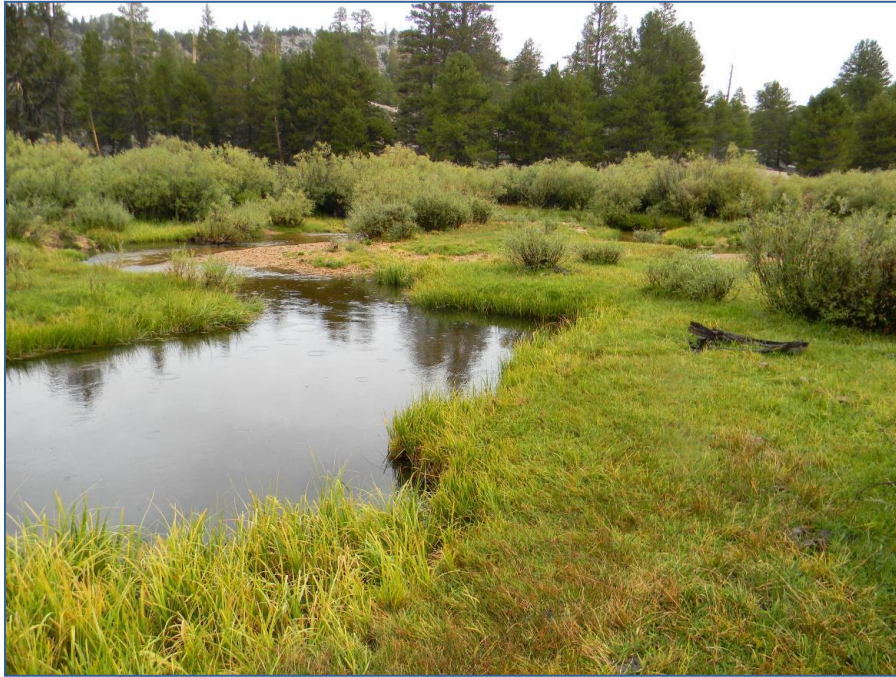
PFC Rating: The portion of Mulkey Creek that flowed through Overholster Meadow was rated at Proper Functioning Condition. Some lateral movement of the channel was observed, with well-vegetated banks on the inside bend, indicating an increase in sinuosity. Large fish were observed in this reach, with abundant pools, cover, and spawning sites. Streambanks and floodplain were heavily vegetated with a multiple age-class willow stand.

Photo above: Mulkey Creek through Overholster Meadow. Some areas of recent deposition were evident.

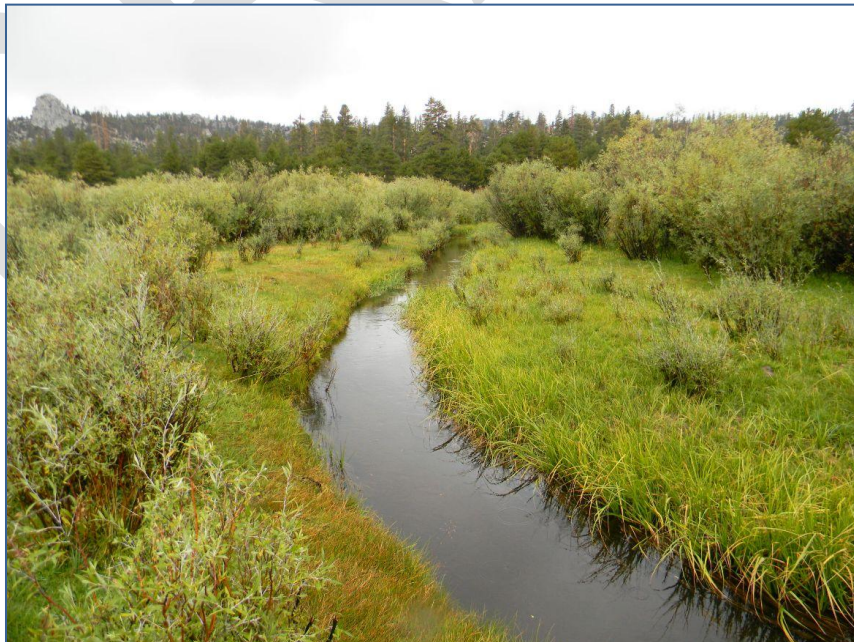
Photo above: Mulkey Creek through Overholster Meadow. This flowed through the ecological type MU12.

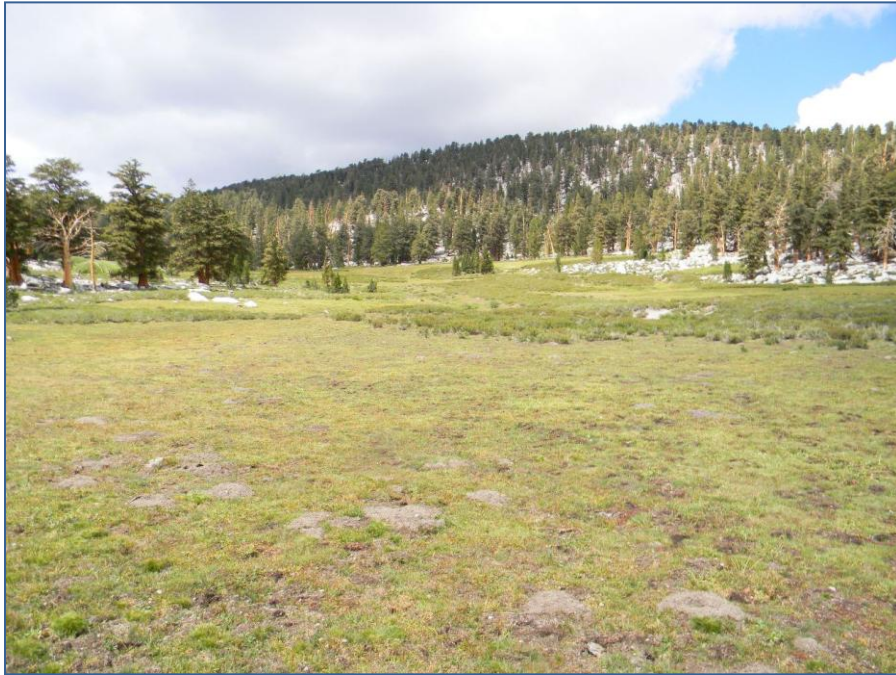
- **Bare ground:** Abundant rodent activity throughout the meadow was observed, mostly concentrated in the upper terraces where the vegetation was characteristically more a “dry” ecological type.

Photo above: Overview of dry portion of the meadow showing abundant rodent activity.

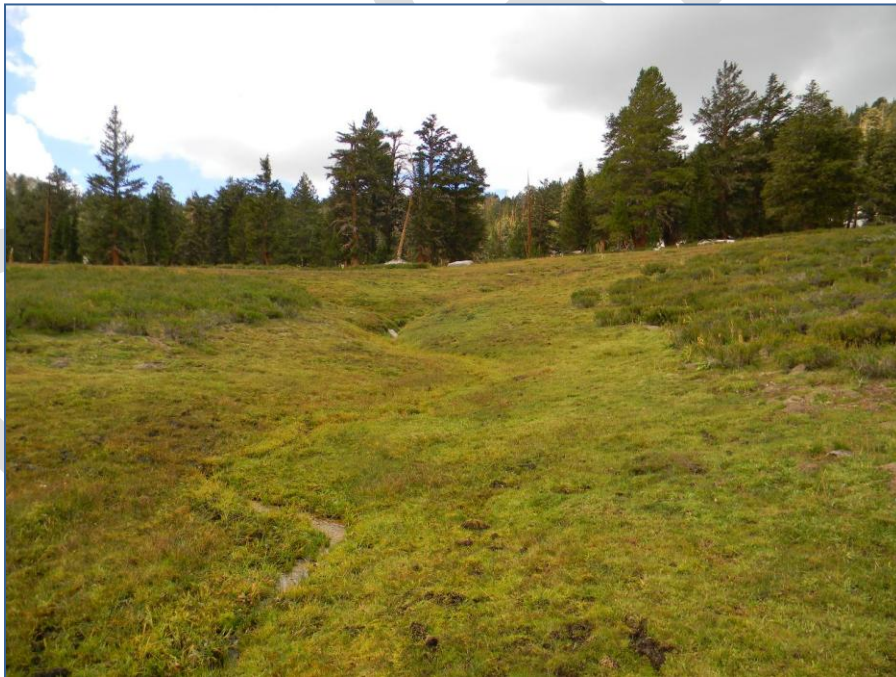
Photo above: Small spring channel flowing from spring "bench" area at top of Poison Meadow.

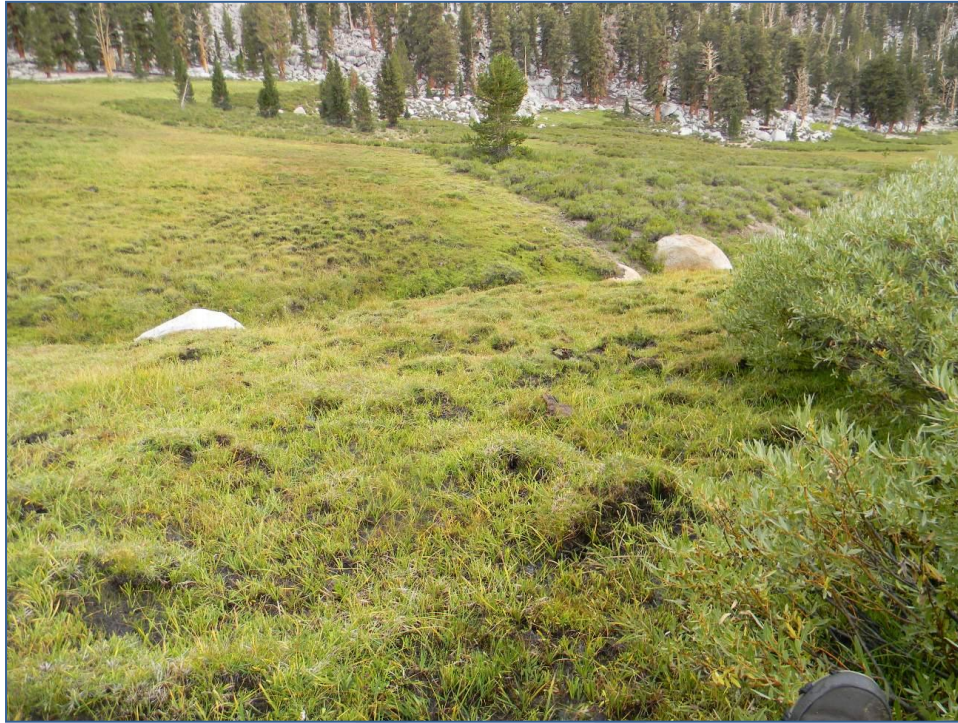
- **Hummocks:** There were areas of hummocks throughout the upper portion of the meadow within wet areas, but not in all wet areas or springs. Some change of vegetation species was noted on top of hummocks, but these were still “wet dependent” species.

Photo above: Hummock areas on the spring “bench” with rodent activity observed throughout area.

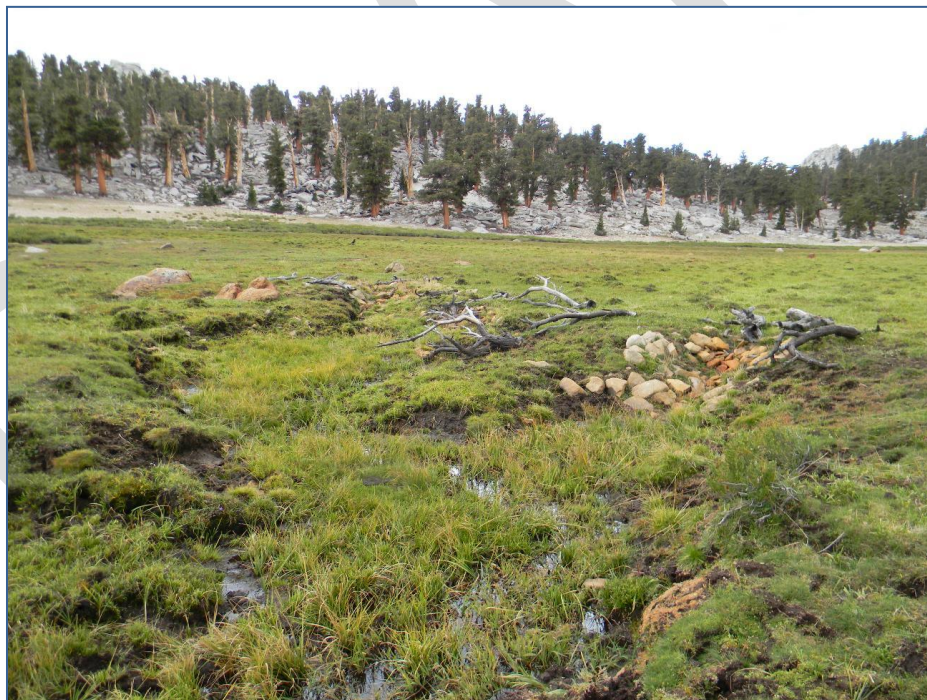
- **Headcuts:** Nickpoints were observed throughout the spring channels but appeared well-vegetated and stable in the upper portion of the meadow. Some movement of the treated headcuts was observed in the lower portion of the meadow, with abundant rodent activity observed around the margins of the headcut/treatment area. Cattle trampling superimposed on the rodent burrowing caused a more unstable condition along the headcut margins.

Photo above: Treated headcuts within Poison Meadow. Rodent activity coupled with the wet summer and the overlay of cattle trampling was evident by the bare soil. However, even with these factors, the headcuts did not migrate and remained stable during 2011.
